COLUMBIA

ACCIDENT INVESTIGATION REPORT

REPORT VOLUME 1
AUGUST 2003

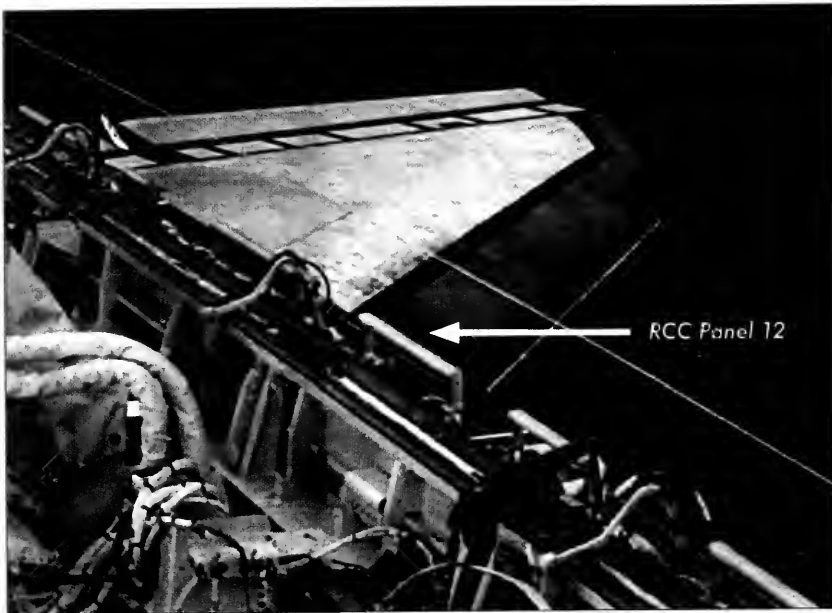
This photo from the aft flight deck window of an Orbiter shows that RCC panels 1 – 11 are not visible from inside the Orbiter. Since Columbia did not have a manipulator arm for STS-107, it would have been necessary for an astronaut to take a spacewalk to visibly inspect the inboard leading edge of the wing.

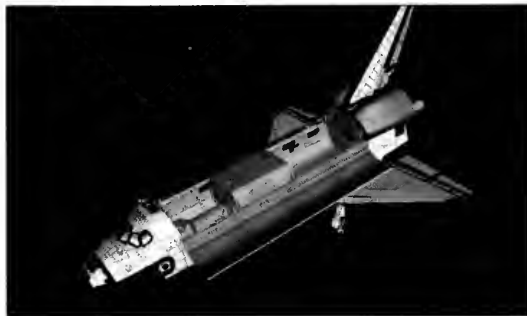
Figure 6.4-1. The speculative repair option would have sent astronauts hanging over the payload bay door to reach the left wing RCC panels using a ladder scavenged from the crew module.

The repair option (see Figure 6.4-1), while logistically viable using existing materials onboard *Columbia*, relied on so many uncertainties that NASA rated this option "high risk." To complete a repair, the crew would perform a spacewalk to fill an assumed 6-inch hole in an RCC panel with heavy metal tools, small pieces of titanium, or other metal scavenged from the crew cabin. These heavy metals, which would help protect the wing structure, would be held in place during

re-entry by a water-filled bag that had turned into ice in the cold of space. The ice and metal would help restore wing leading edge geometry, preventing a turbulent airflow over the wing and therefore keeping heating and burn-through levels low enough for the crew to survive re-entry and bail out before landing. Because the NASA team could not verify that the repairs would survive even a modified re-entry, the rescue option had a considerably higher chance of bringing *Columbia*'s crew back alive.

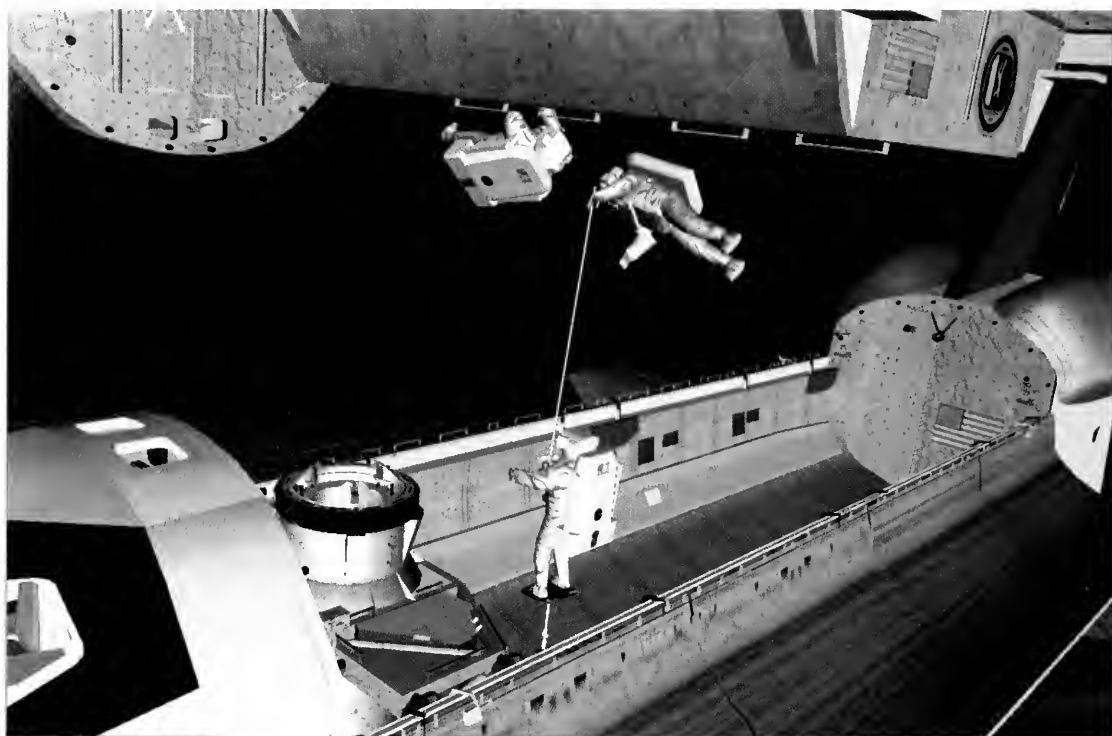
Figure 6.4-2. The rescue option had Atlantis (lower vehicle) rendezvousing with Columbia and the STS-107 crew transferring via ropes. Note that the payload bay of Atlantis is empty except for the external airlock/docking adapter.

er, pilot, and two astronauts trained for spacewalks. In January, seven commanders, seven pilots, and nine spacewalk-trained astronauts were available. During the rendezvous on Atlantis's first day in orbit, the two Orbiters would maneuver to face each other with their payload bay doors open (see Figure 6.4-2). Suited Columbia crew members would then be transferred to Atlantis via spacewalks. Atlantis would return with four crew members on the flight deck and seven in the mid-deck. Mission Control would then configure Columbia for a de-orbit burn that would ditch the Orbiter in the Pacific Ocean, or would have the Columbia crew take it to a higher orbit for a possible subsequent repair mission if more thorough repairs could be developed.

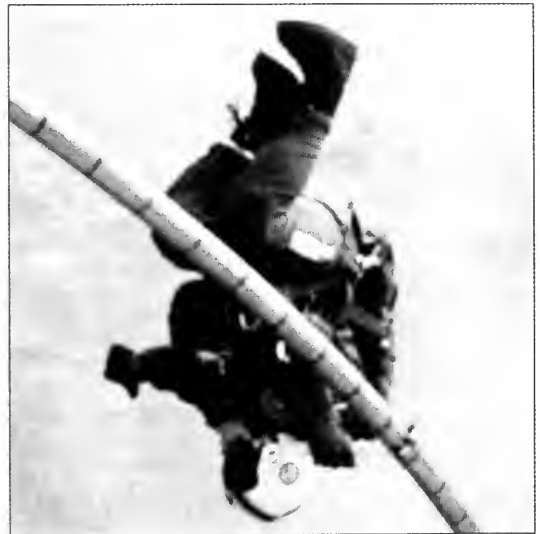
In response to this recommendation, NASA developed the current “pole bailout” system for use during controlled, subsonic gliding flight (see Figure 10.2-1). The system requires crew members to “vent” the cabin at 40,000 feet (to equalize the cabin pressure with the pressure at that altitude), jettison the hatch at approximately 32,000 feet, and then jump out of the vehicle (the pole allows crew members to avoid striking the Orbiter’s wings).

Figure 10.2-1. A demonstration of the pole bailout system. The pole is extending from the side of a C-141 simulating the Orbiter, with a crew member sliding down the pole so that he would fall clear of the Orbiter’s wing during an actual bailout.

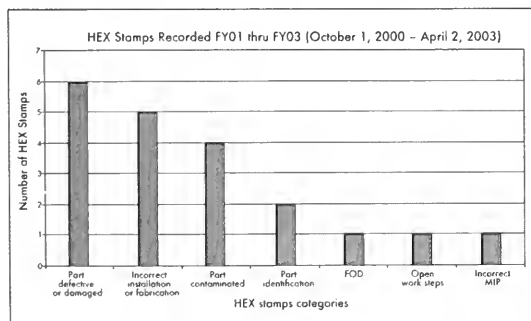
Of the 141,127 inspections subject to rejection from October 2000 through March 2003, only 20 rejections, or "hexes," were recorded, resulting in a statistically improbable discrepancy rate of .014 percent (see Figure 10.4-4). In interviews, technicians and inspectors alike confirmed the dubiousness of this rate. NASA's published rejection rate therefore indicates either inadequate documentation or an underused system. Testimony further revealed incidents of quality assurance inspectors being played against each other to accept work that had originally been refused.

Figure 10.4-4. Rejection, or "Hex" stamps issued from October 2000 through April 2003.
